# Attachment “A”

## ASBESTOS PROGRAM SUMMARY

### Administration Building

### BUILDING 8, ADMINISTRATION BUILDING

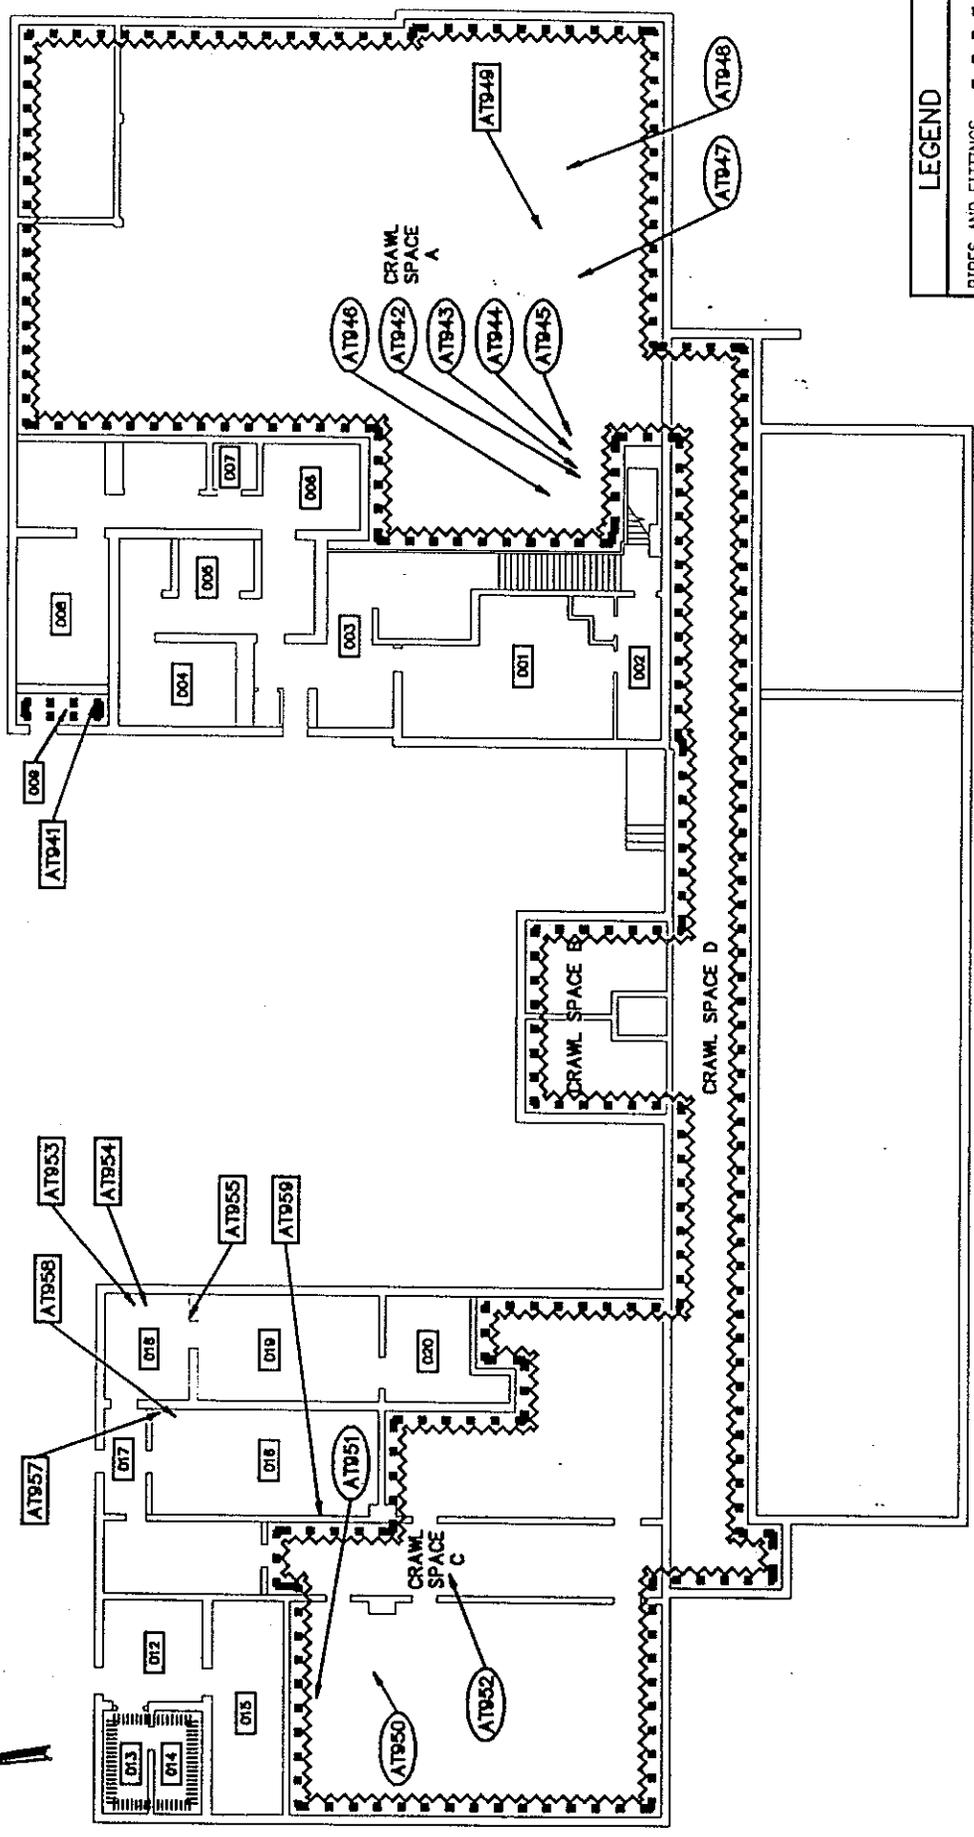
FIGURE 11.1

The crawl spaces located under the building contain large quantities of asbestos-containing pipe insulation. This insulation is in very poor condition and has fallen from areas of the pipe system. The pipe system configuration suggests that some pipes are located in the walls throughout this building. To sample and check for asbestos on these pipes would require destructive testing. Until proven otherwise, it should be assumed there is asbestos pipe insulation contained inside the walls.

The fallen insulation has contaminated the soil. This contaminated soil possesses a significant hazard to anyone entering the area to perform repair work.

Other suspect material including sheetrock, ceiling tile, floor tile, various ceiling materials, and roofing shingles were found not to contain asbestos. Figure 11.1 indicates the sample locations.

Table 11.2 lists the types, locations and quantities of the ACM. The locations and material types are shown in the schematic floor plan drawing, on Figure 11.1. A summary of ACM found in this building follows:

The crawl spaces need to receive high priority for abatement action. The County of York has taken proper steps in sealing this area off from air movement and access to people, however, the material still remains. Air samples should be taken from areas around entrances to the crawl spaces to check for airborne asbestos fibers and to check if the seals are adequate.

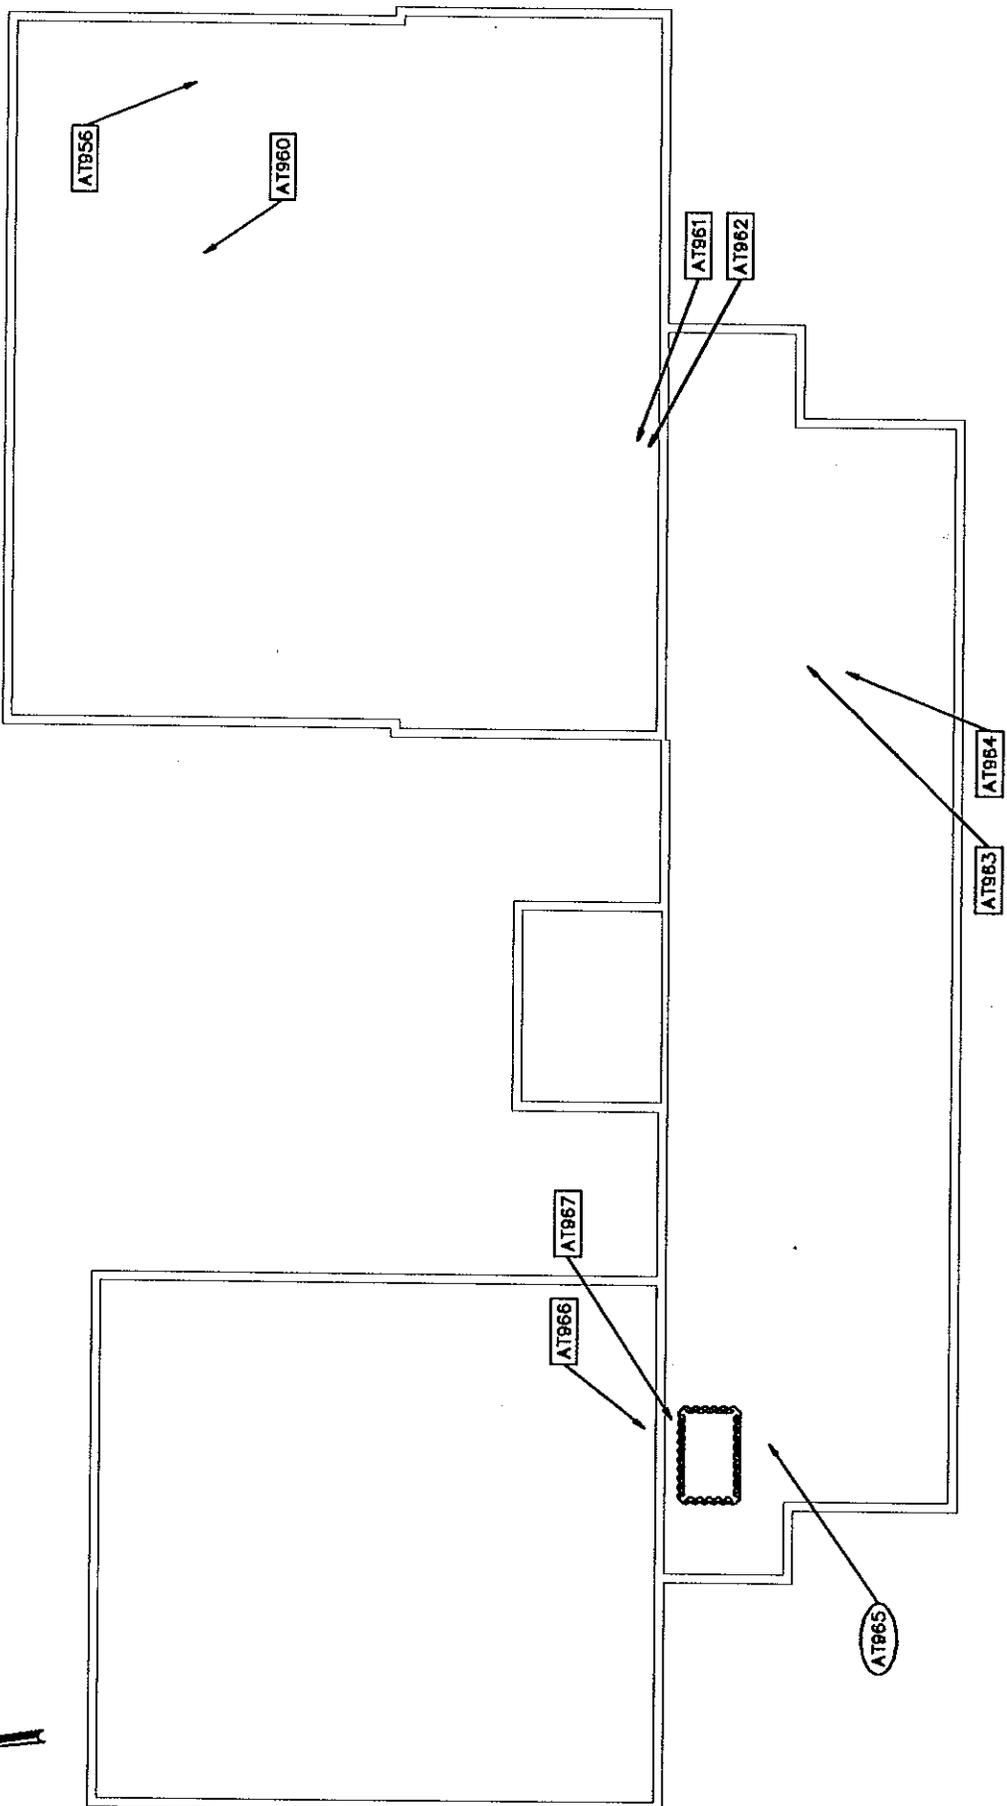
FIGURE 11.1

Some sealing caulk found on the air conditioning unit located on the roof was found to contain asbestos. The caulk was used to seal metal joints and create a weather proof seal. The caulk is non-friable.

Transite paneling was reported in the basement. These panels are completely enclosed behind sheetrock.

The floor sheeting and caulk material are non-friable and no action is necessary. The floor sheeting is covered by carpeting and is not likely to release any fibers. The caulk is an exterior material and in normal use will not become friable. Prior to renovation, the floor sheeting should be removed. The caulk will not need to be removed because it will not become friable during renovation or demolition.

The transite paneling and roofing materials assumed to contain asbestos will need to be removed prior to renovation or demolition that will affect the material.
