# COUNTY OF YORK

# Colonial Behavioral Health

# Space Needs Analysis

# PROPERTY CONDITION SURVEY

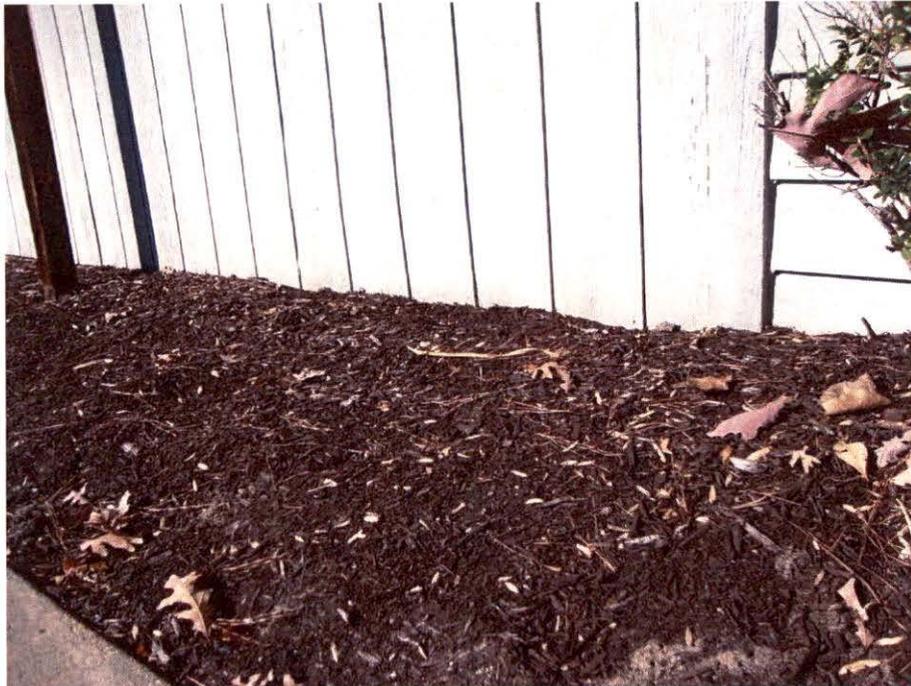
Photo 1: Typical view of mulch up against siding at 1657 Merrimac Trail.

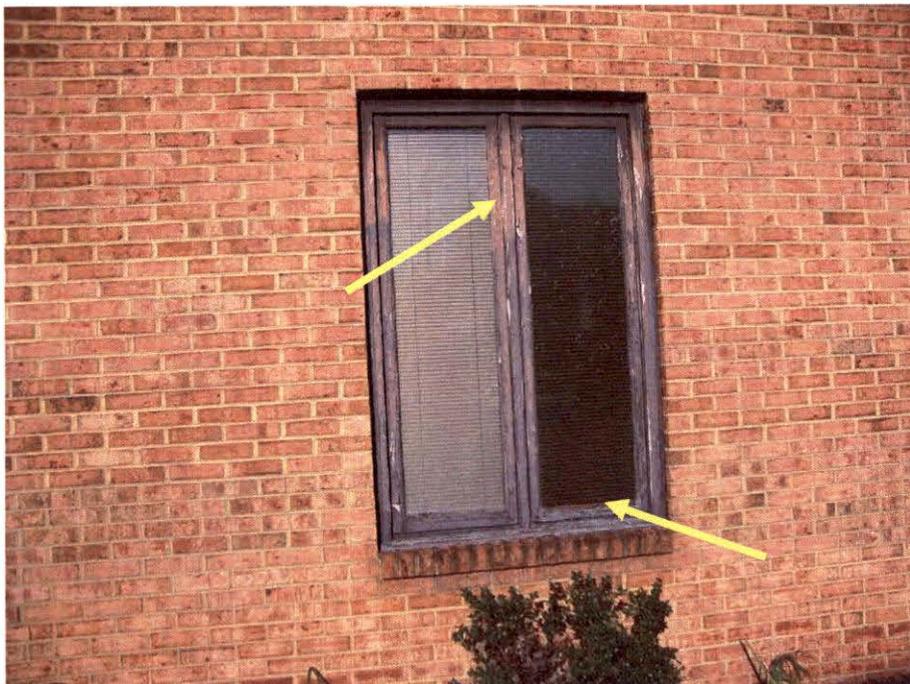
Photo 2: Typical view of window degradation at 1657 Merrimac Trail.

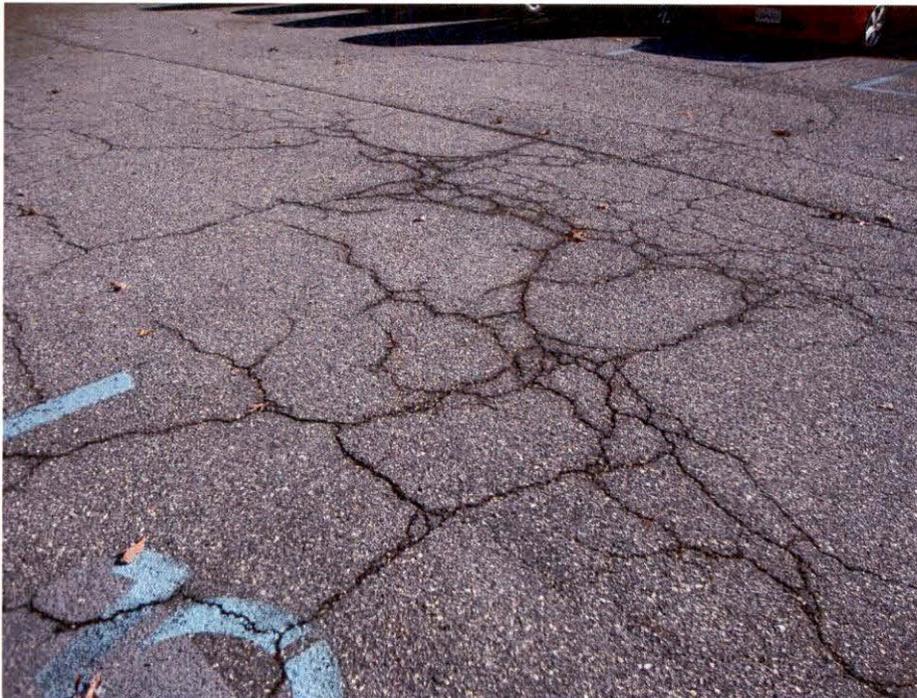
Photo 3: Typical view of asphalt cracking in parking lot area of 1657 Merrimac Trail.

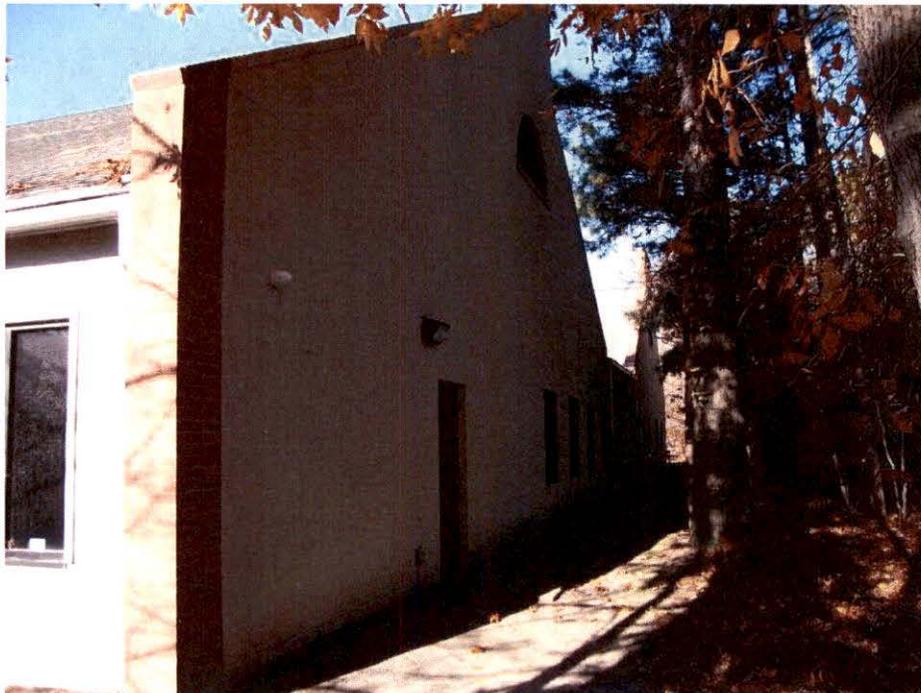
Photo 4: Trees encroaching foundation of 1651 Merrimac Trail Bldg. and also causing damage to roof systems from falling branches.

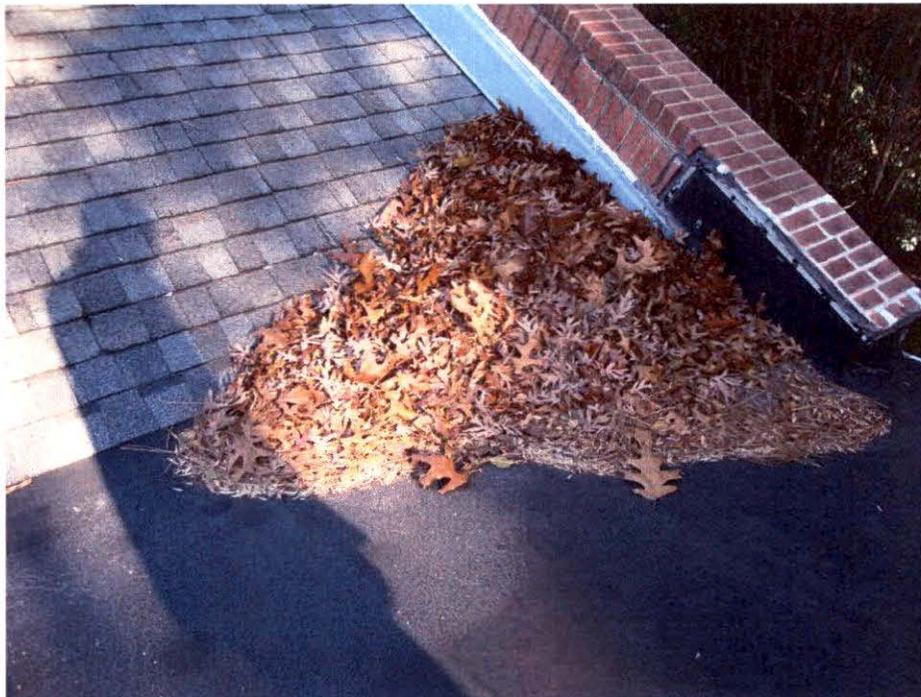
Photo 5: Leaf accumulation on EPDM roof of 1651 Merrimac Trail Bldg. causing potential drainage problems.

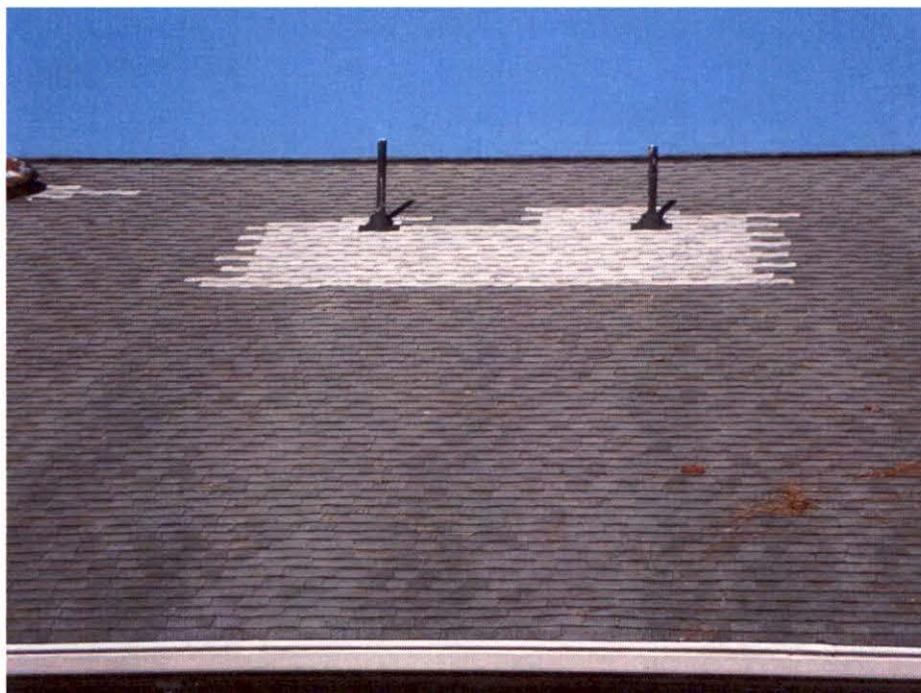
Photo 6: Patched section of 1651 Merrimac Trail Bldg., cause may have been from falling tree limbs.

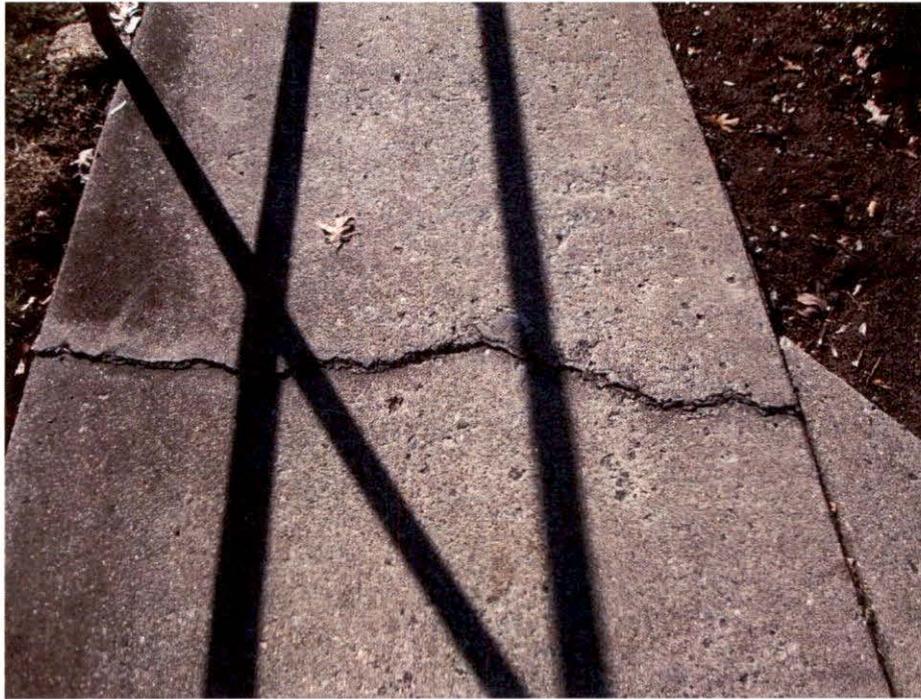
Photo 7: Crack in sidewalk in front of 1651 Merrimac Trail Bldg.

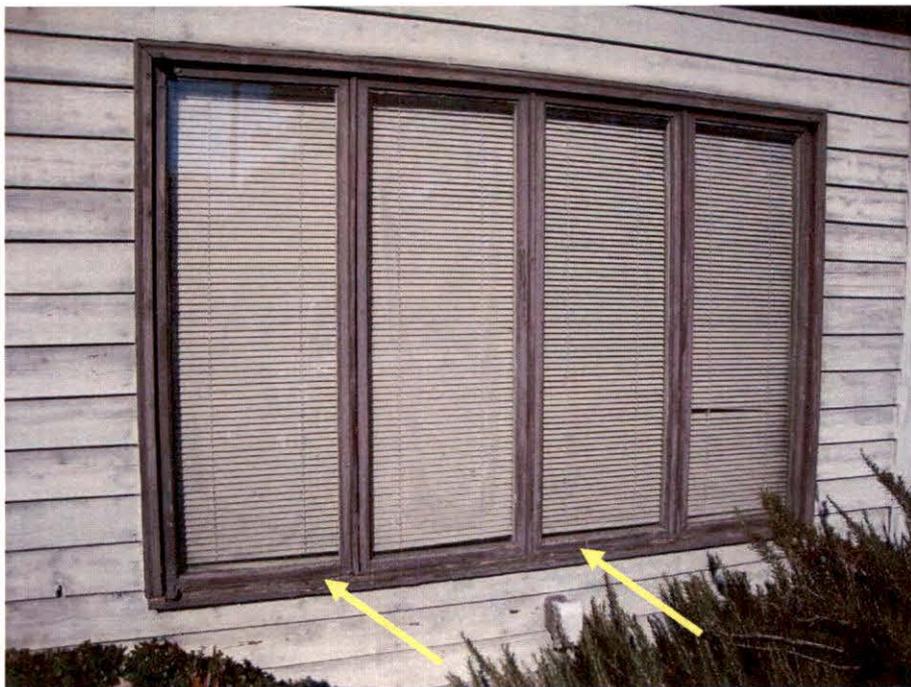
Photo 8: Typical view of window degradation at 1659 Merrimac Trail.

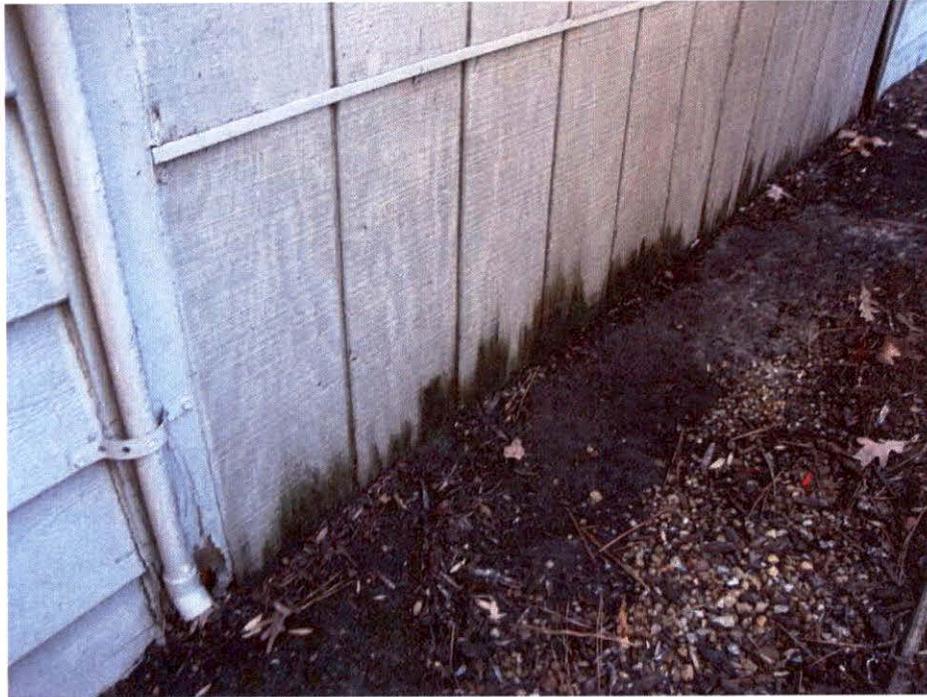
Photo 9: Typical view of mulch up against siding at 1659 Merrimac Trail Bldg. and siding damage due to buildup.

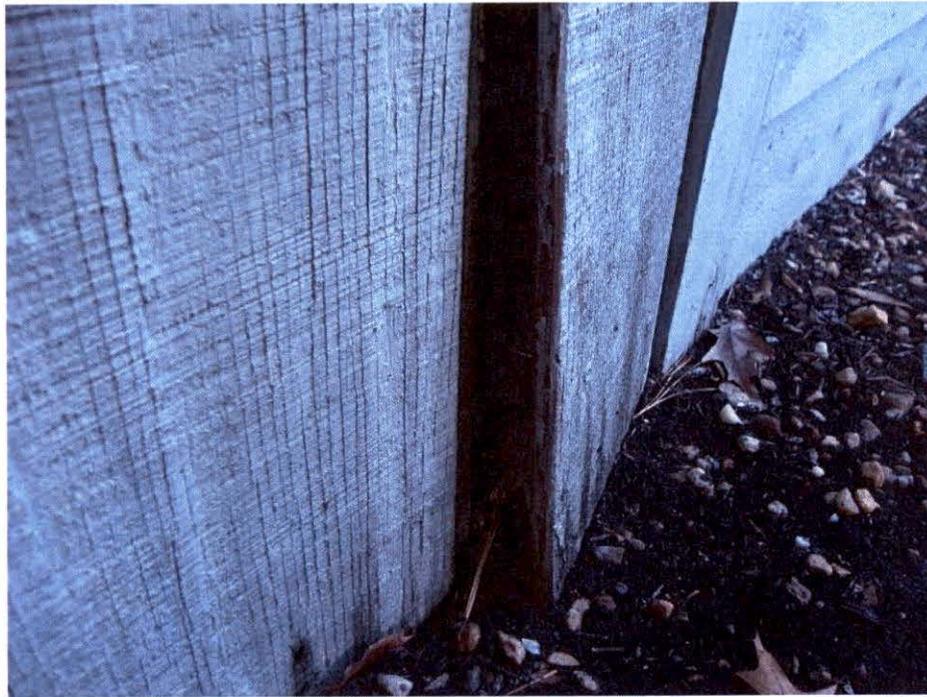
Photo 10: Damage to siding due to mulch buildup at 1659 Merrimac Trail Bldg.

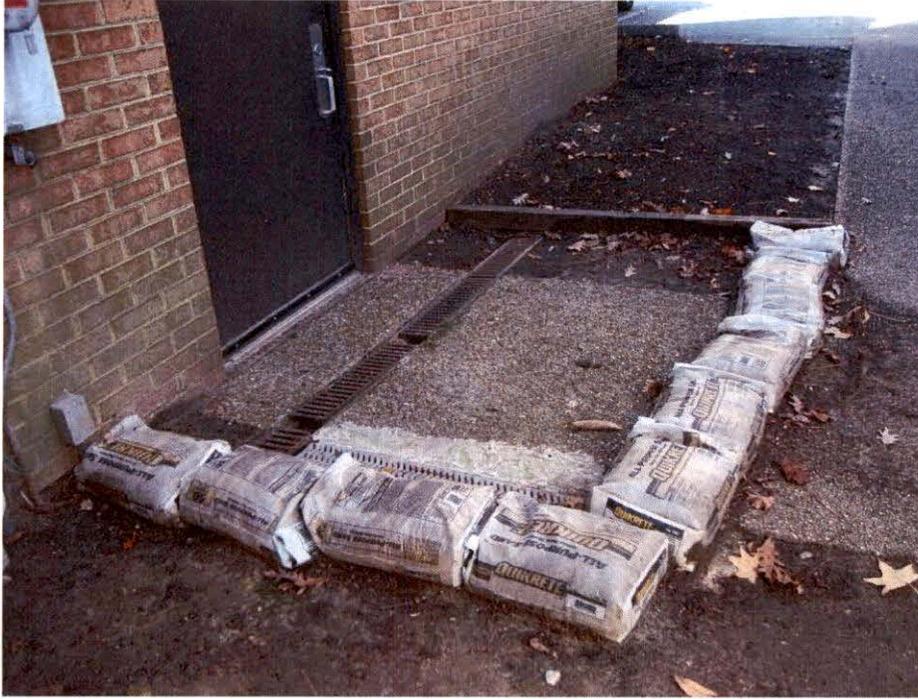
Photo 11: View of barrier around door due to failed or undersized drain and poor grading around the building perimeter at 1659 Merrimac Trail Bldg.

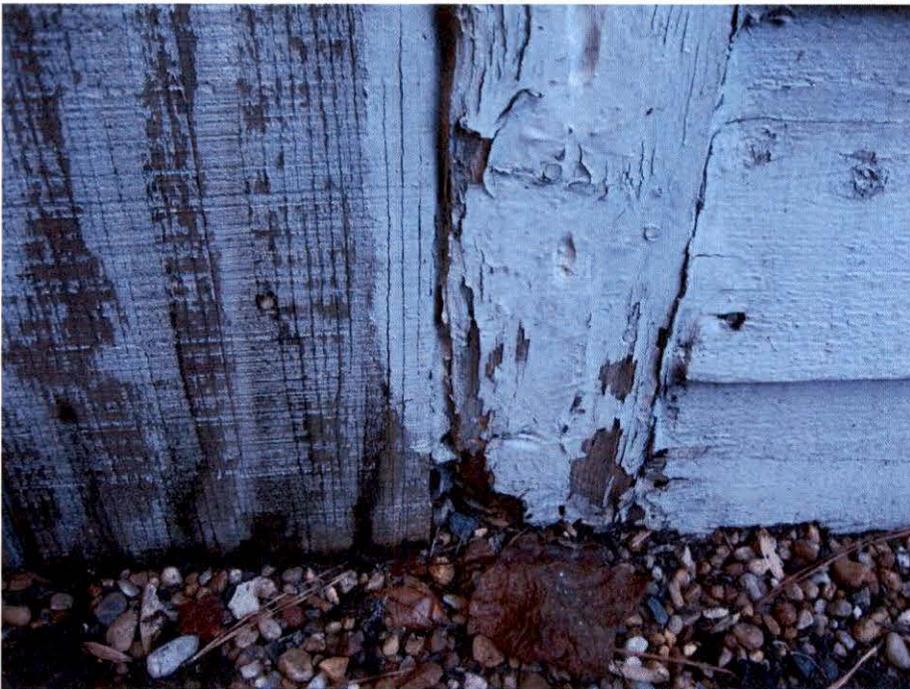
Photo 12: Damage to siding due to contact with ground and deferred maintenance at 1659 Merrimac Trail Bldg.

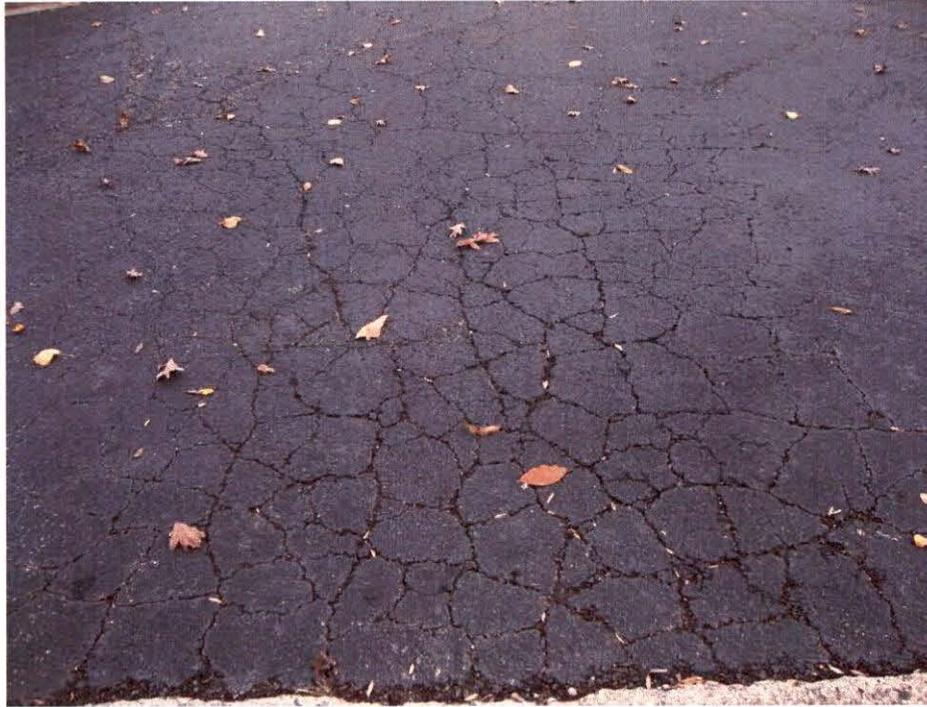
Photo 13: Alligator cracking of asphalt at the end of the concrete dumpster pad at 111 Warwick Court.

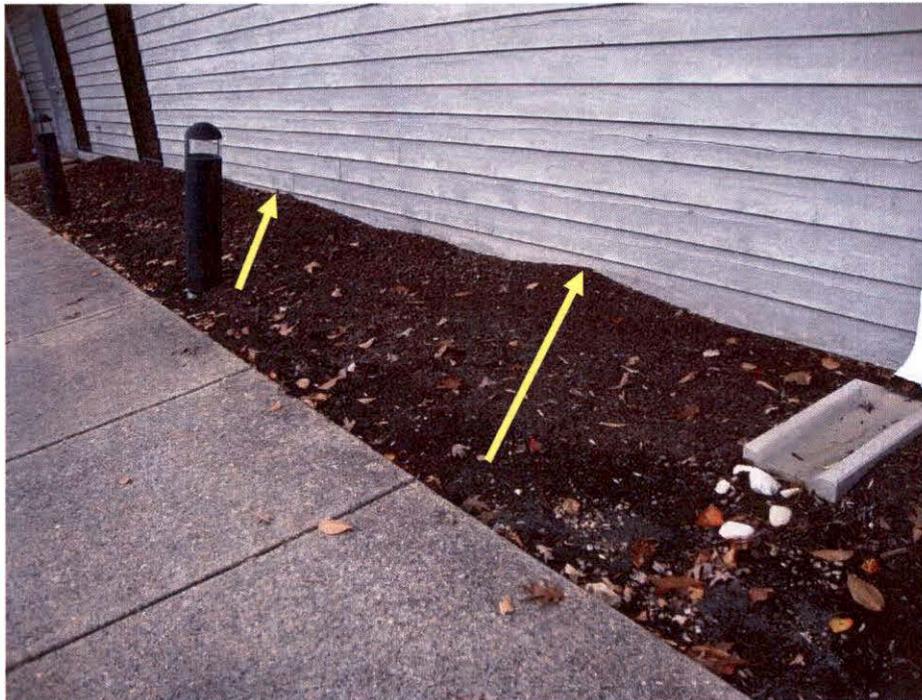
Photo 14: Typical view of mulch up against siding and paint oxidation at 111 Warwick Court.

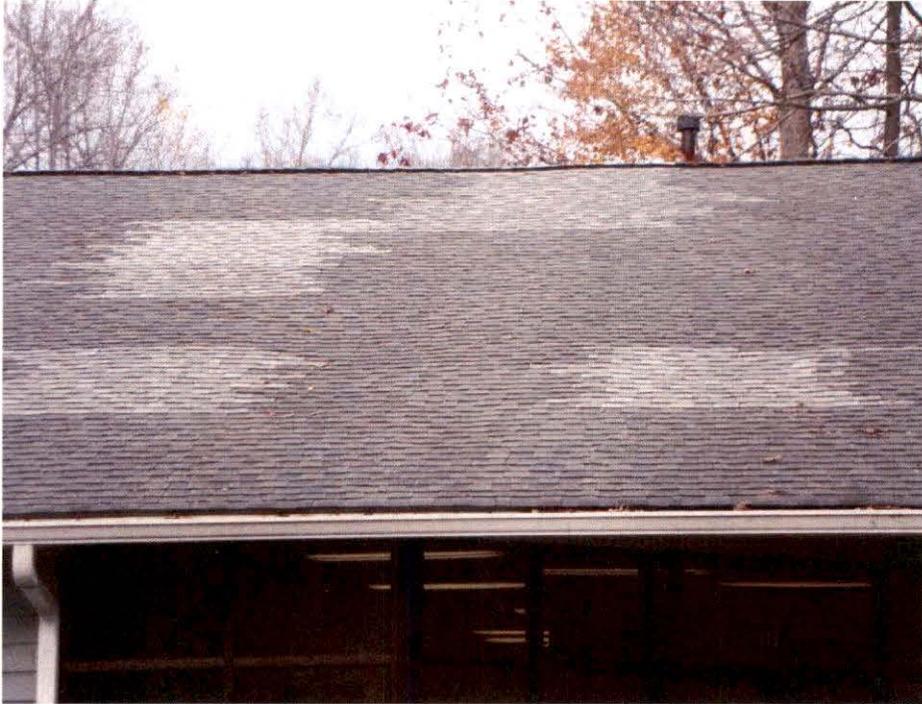
Photo 15: Roof patches at 111 Warwick Court.

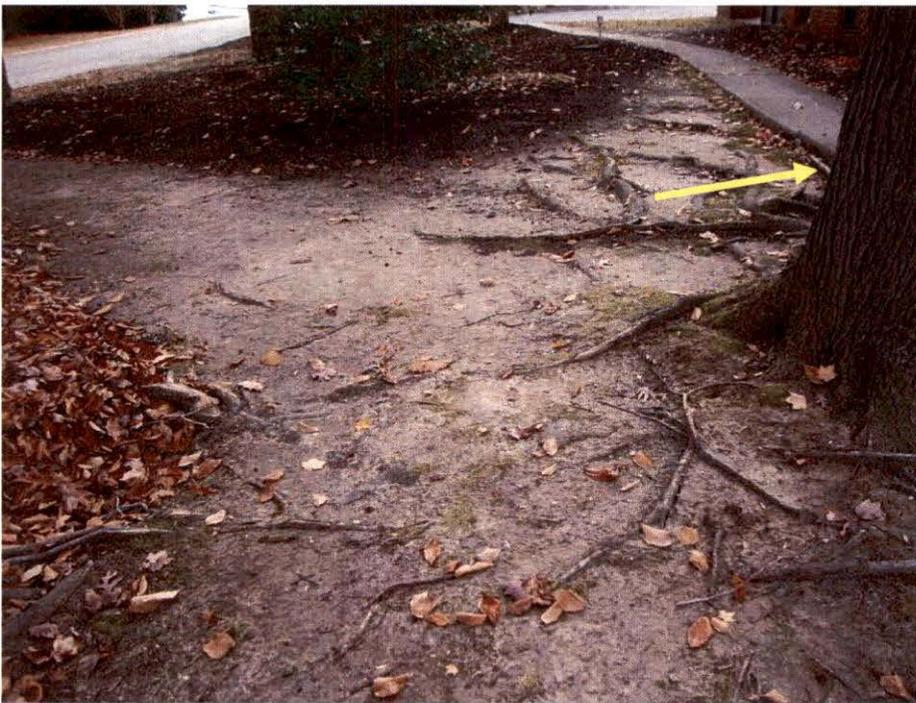
Photo 16: Erosion around trees and potential for roots raising sidewalks at 111 Warwick Court.

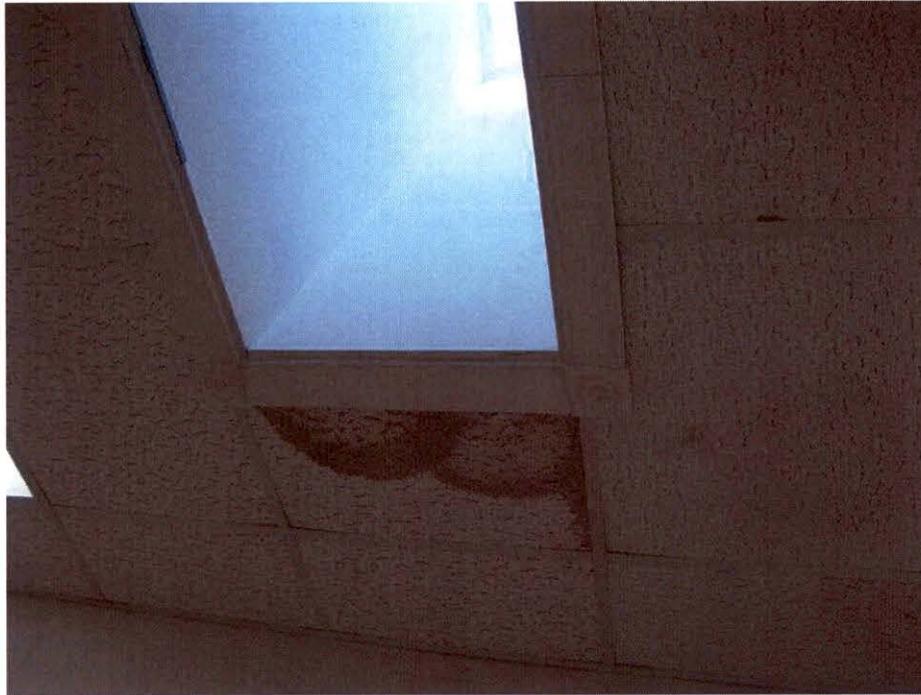
Photo 17: Stained acoustic ceiling tile due to previous leak around skylight at 111 Warwick Court.

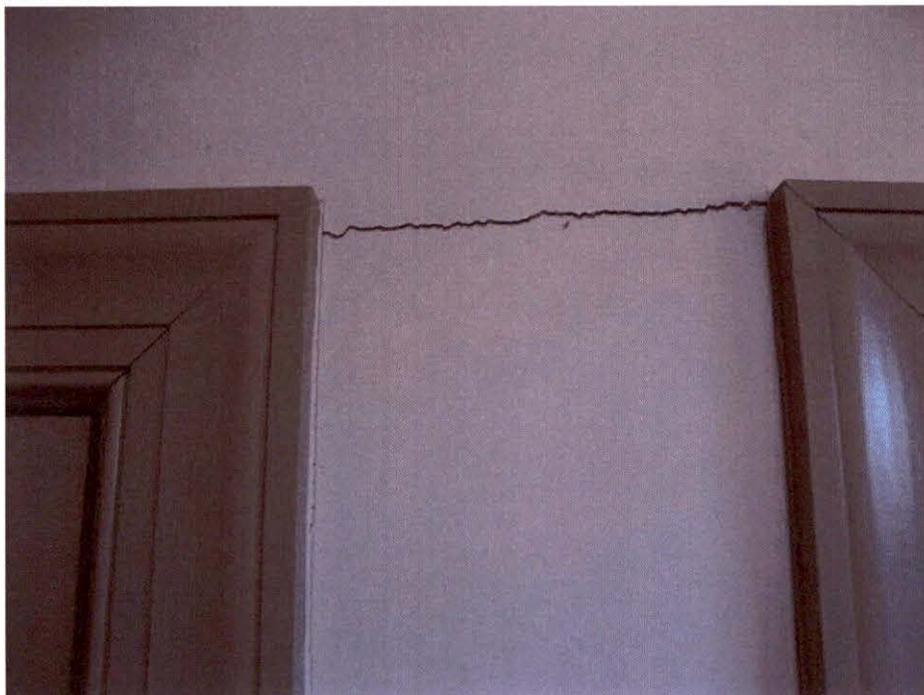
Photo 18: Cracks in drywall due to settlement at 921 Capital Landing Road.

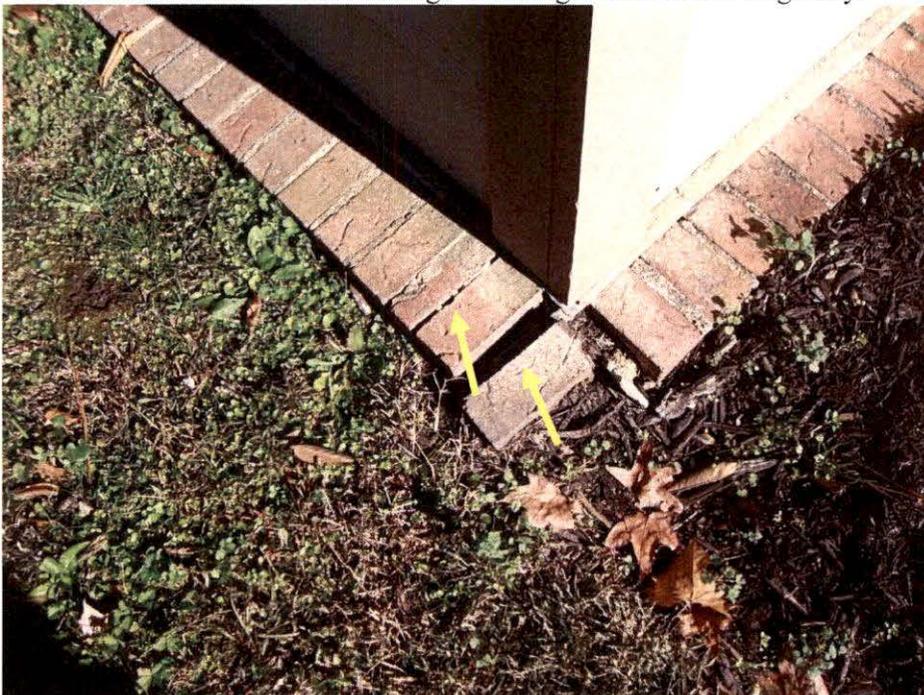
Photo 20: Mortar bond failure and missing brick at outside corner of 3804 George Washington Memorial Highway.

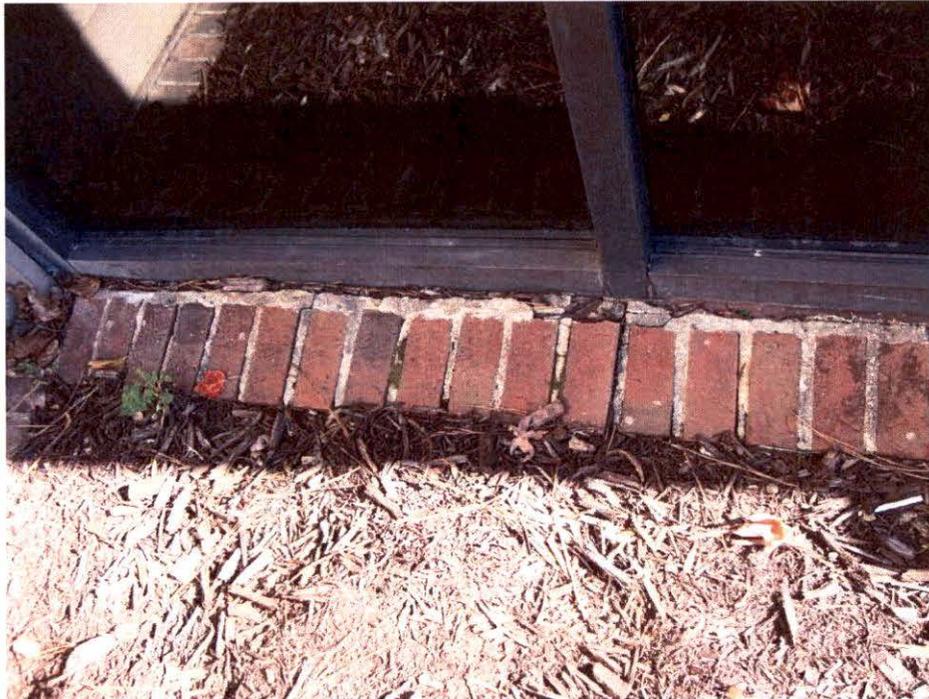
Photo 21: Mortar bond failure at window of 3804 George Washington Memorial Highway.

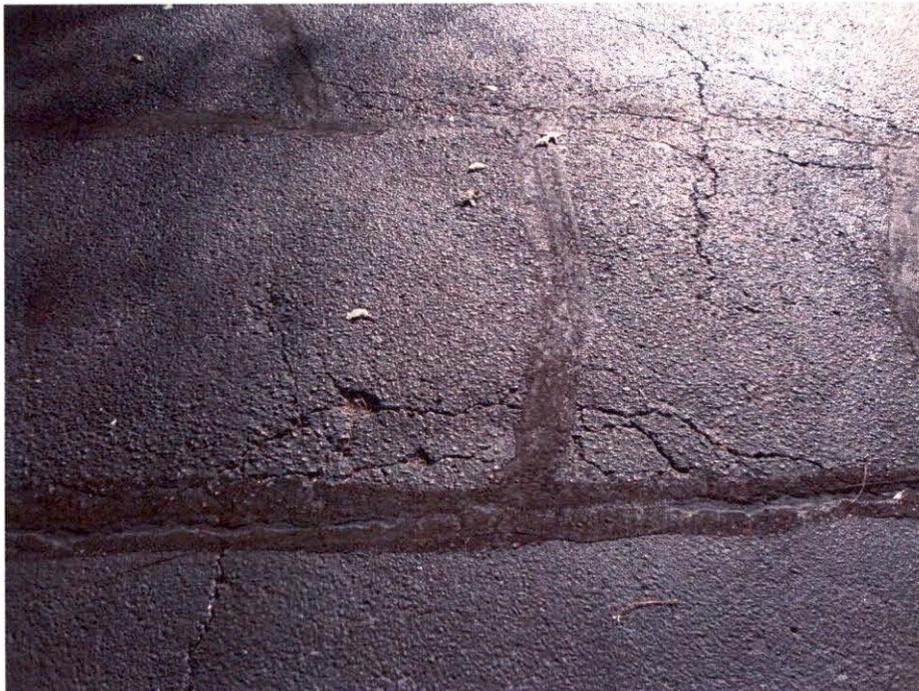
Photo 22: Cracking of asphalt at 11 Warwick Court.

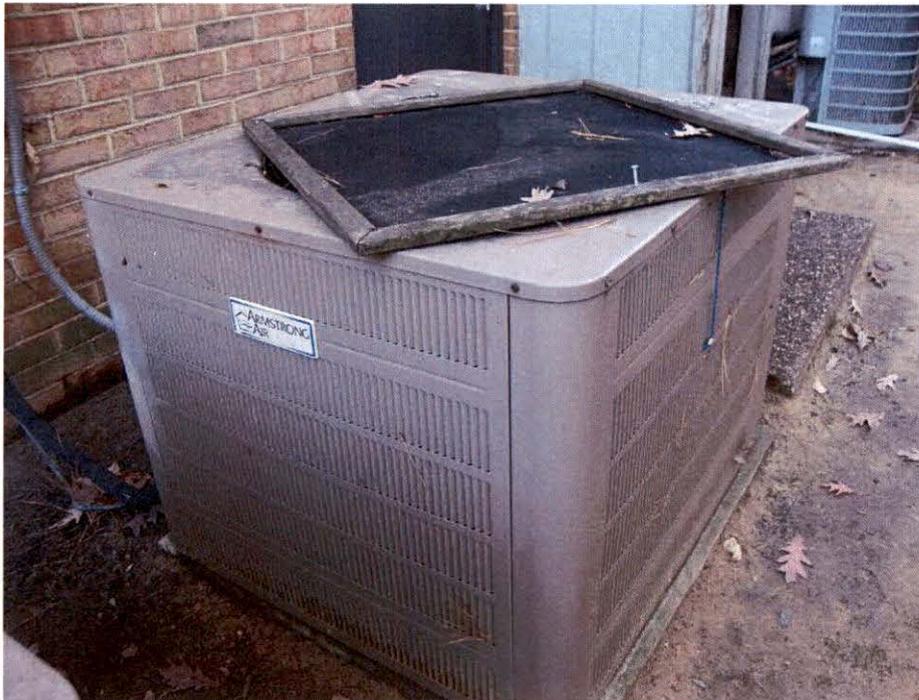
Photo 23: Typical older *Armstrong Air* HVAC condensing unit.

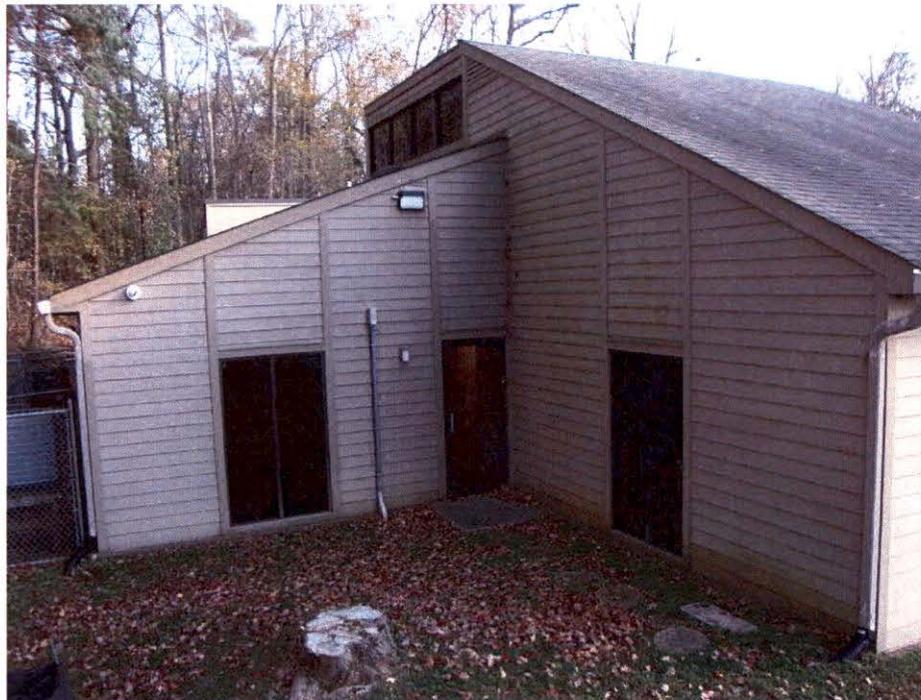
Rear elevation of 3804 George Washington Memorial Hwy showing flat area where storm water accumulates.
