COUNTY OF YORK

DATE: July 30, 2024
TO: York County Board of Supervisors
FROM: Mark L. Bellamy, Jr., County Administrator
SUBJECT: New County Administration Building

YORK COUNTY SPACE NEEDS STUDY

York County Space Needs Study

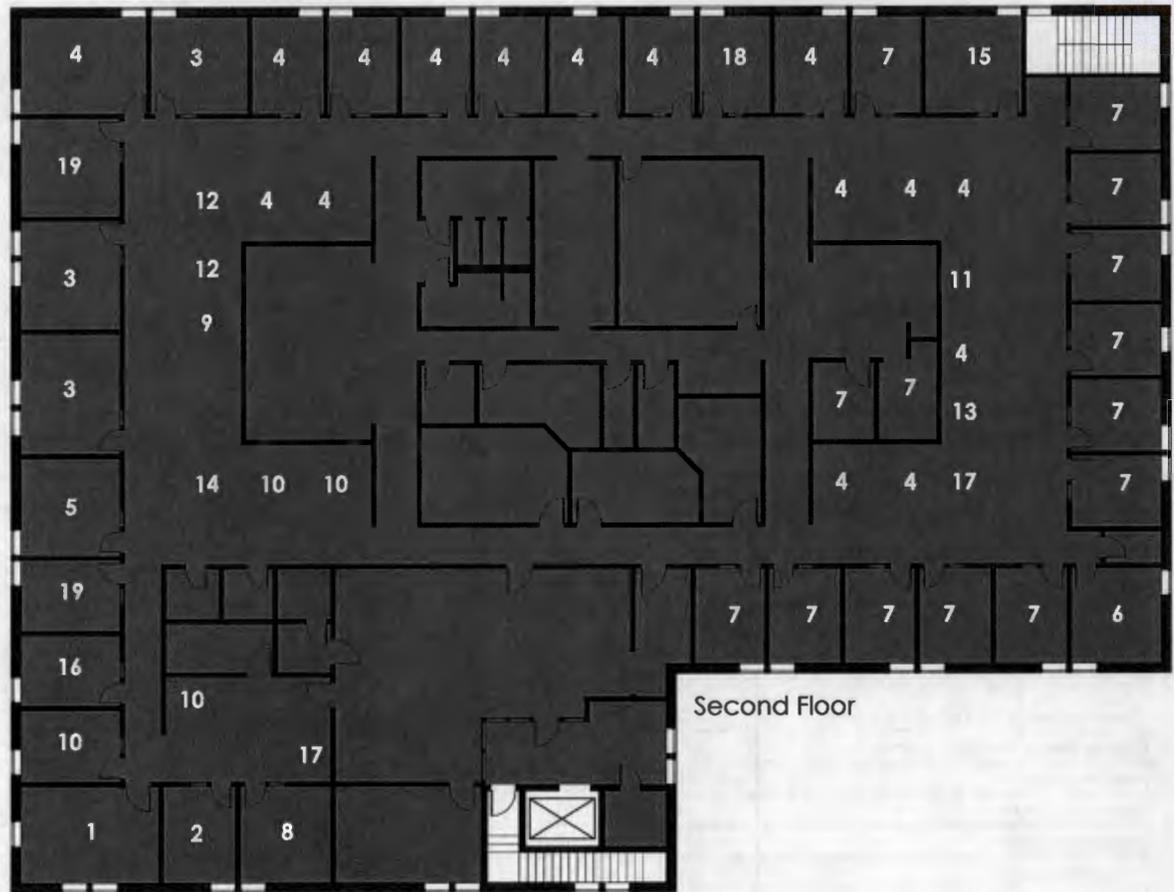
Figure 1.28

Public Safety Building

Social Services

Existing Conditions - The Social Services Department utilizes a total of 12,239 square feet of departmental floor area for 65 employees on the second floor of the Public Safety Building at 301 Goodwin Neck Road, as shown in Figure 1.28. The department is located in the same building that houses the Sheriff as well as the Fire and Life Safety Administrative offices. The department has grown as a result of the recession and is now out of space for efficient operation. Experience with planning social services buildings indicates¹ the average floor space should be 275 square feet per employee for facilities ranging in staff size from 50 to 100. The current facility provides only 188 square feet per employee. More space is needed for client interview rooms, a dedicated Training Room/Board Room, Public Restrooms, Storage areas, a suitably sized breakroom and some increases in office/work area sizes.

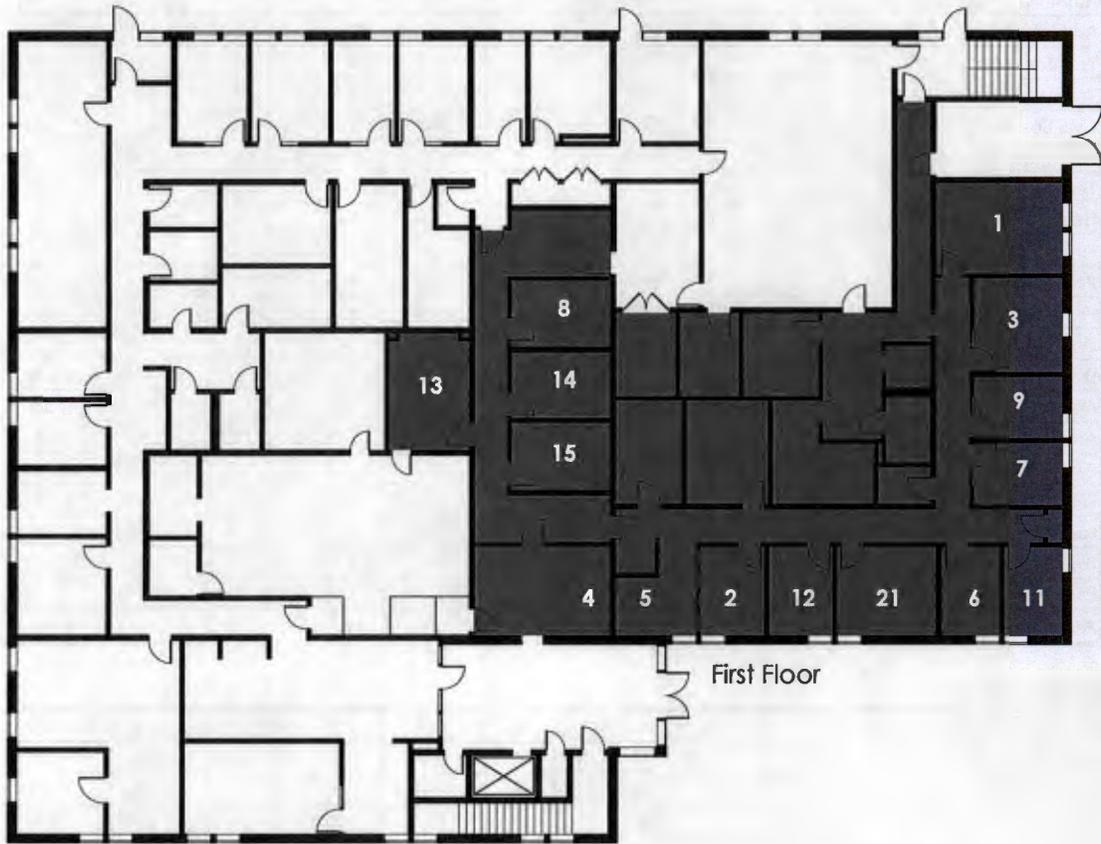
↗^N
Public Safety
Building

■ Fire + Life Safety
Department

Existing Conditions - The Fire and Life Safety Department utilizes a total of 4,110 square feet of total departmental floor area on the first floor of the Public Safety Building at 301 Goodwin Neck Road, as shown in Figure 1.38 and Figure 1.40. The department reports the following issues related to the shortage of space at their current location:

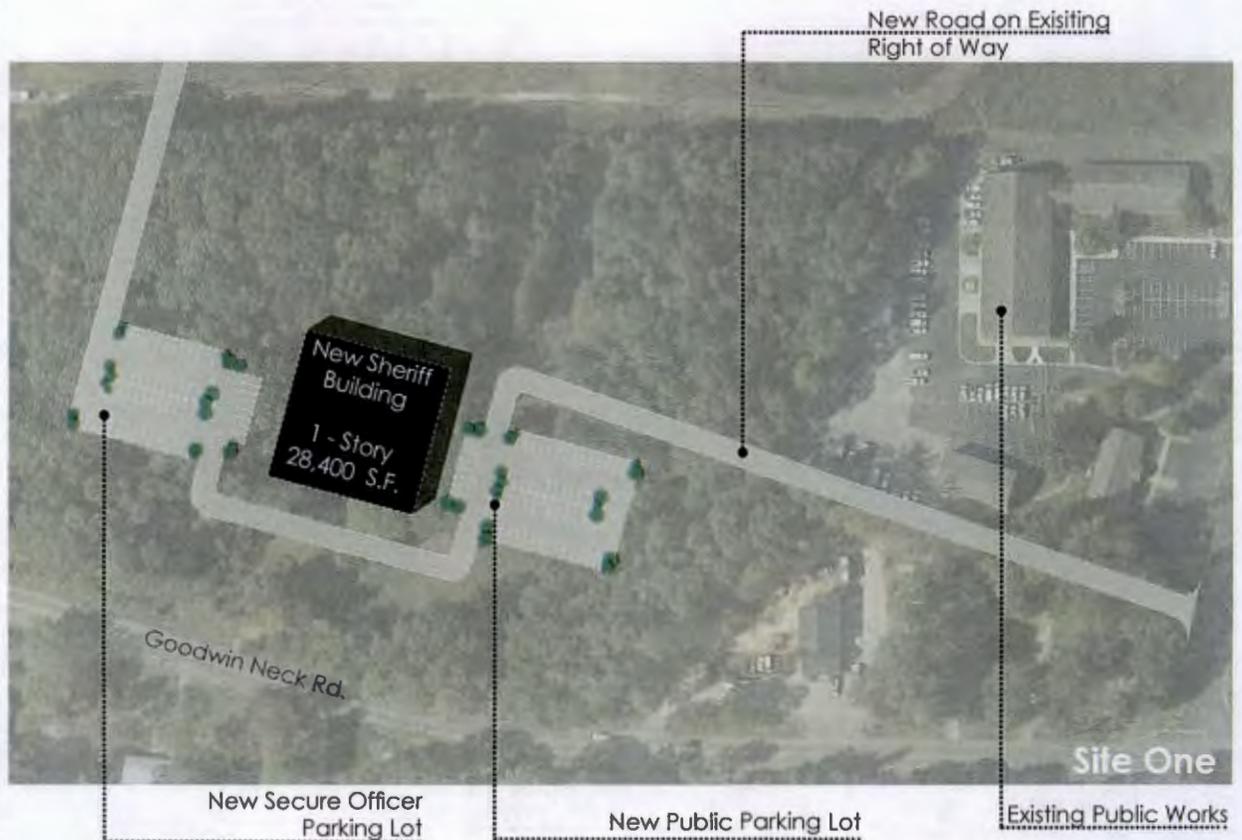
Figure 2.1

Site 1 is behind the existing Public Safety Building on the north side of Operations Drive, as shown in Figure 2.1. Site 1 has the advantage of closer proximity to the E911 center, fuel depot and direct access to the existing entrance to Goodwin Neck Road. This site is somewhat limited in land area and may require a two-story building configuration.

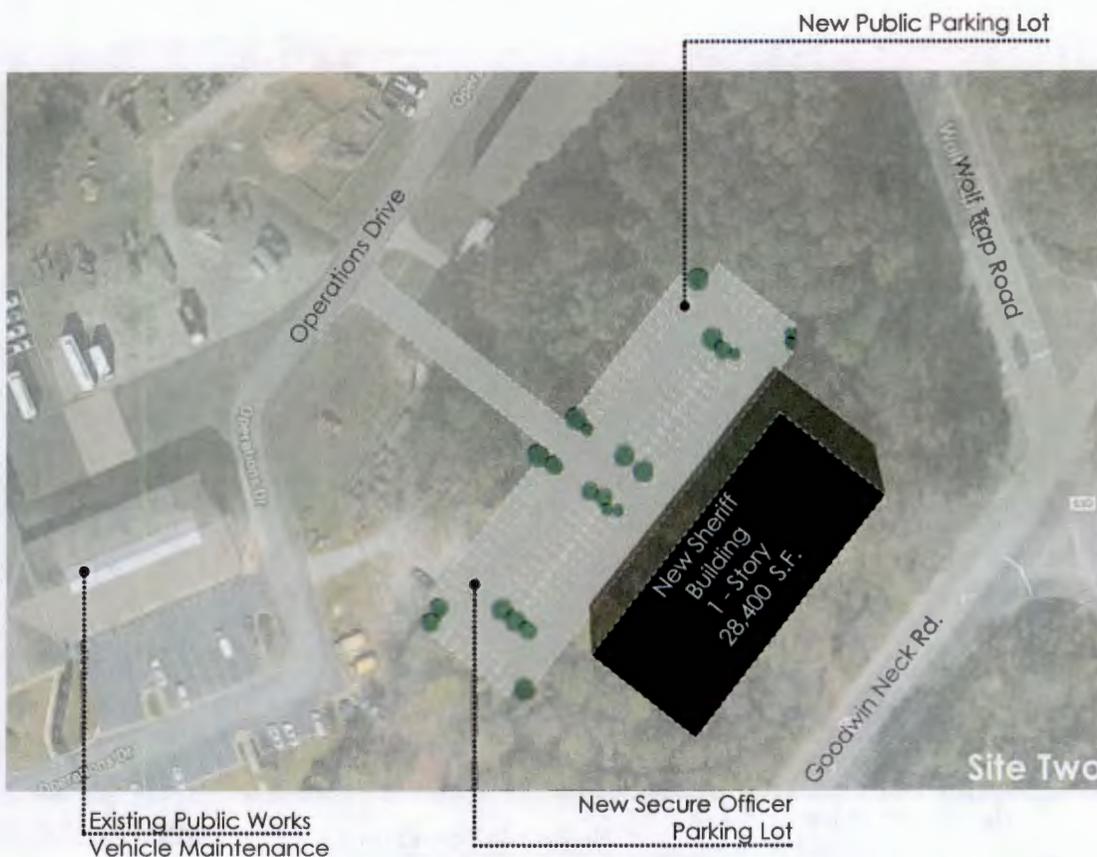
Figure 2.2

Site 2 is located between the corner of Goodwin Neck Road and Wolf Trap Road on existing county owned land. The site appears to be large enough to accommodate a 1 story building with associated parking while still leaving room for future expansion.

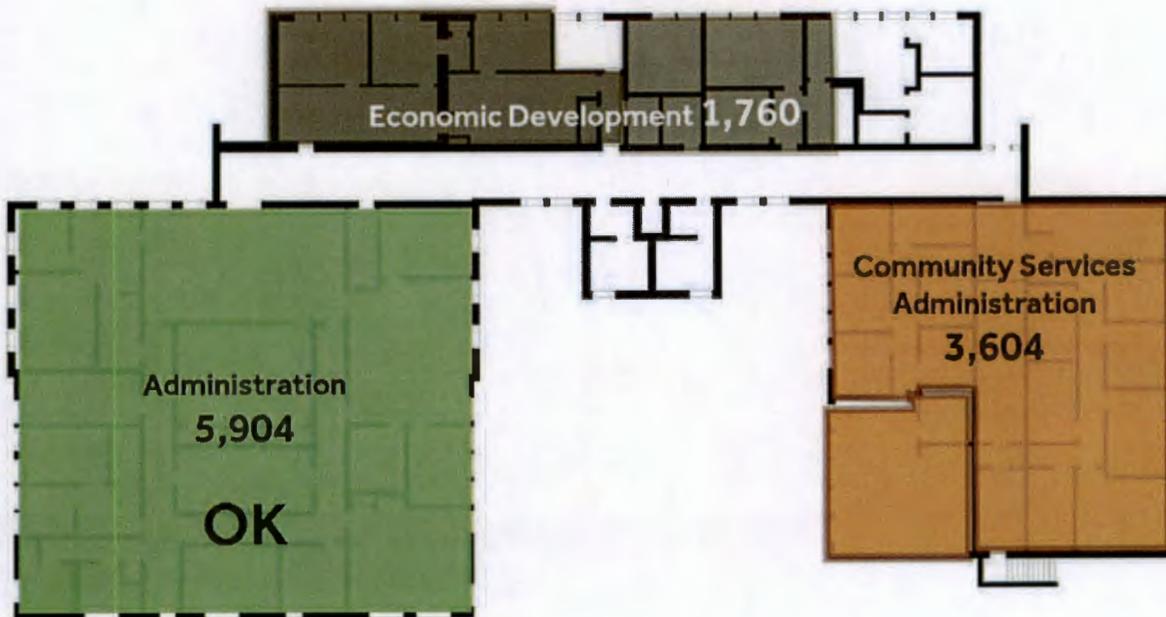
Figure 2.7

Option 1 – This option proposes relocating the Registrar to another location and utilizing the Administrative Office Building for Administration, Economic Development and Community Services Administration, as shown in Figure 2.7. In this option, Economic Development would expand into the area vacated by the Registrar and Community Services Administration would eventually expand into the training room being used jointly for the county-wide accounting system training.

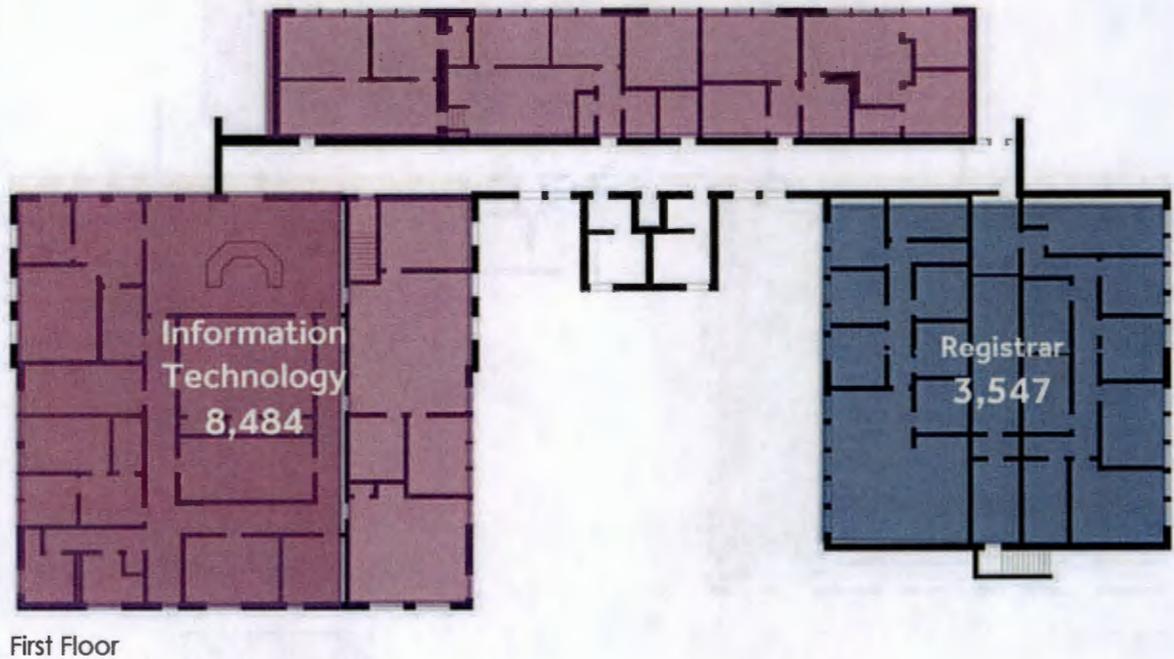
Figure 2.8

Option 2 - This option considers moving the Administrative offices and Economic Development out of the building and reusing the building to consolidate the Information Technology Department and the Registrar, as shown in Figure 2.8. In this scenario, there is sufficient area to locate the entire IT Department at this location and meet the space requirements for the Registrar. Administration and Economic Development would be relocated in this option.

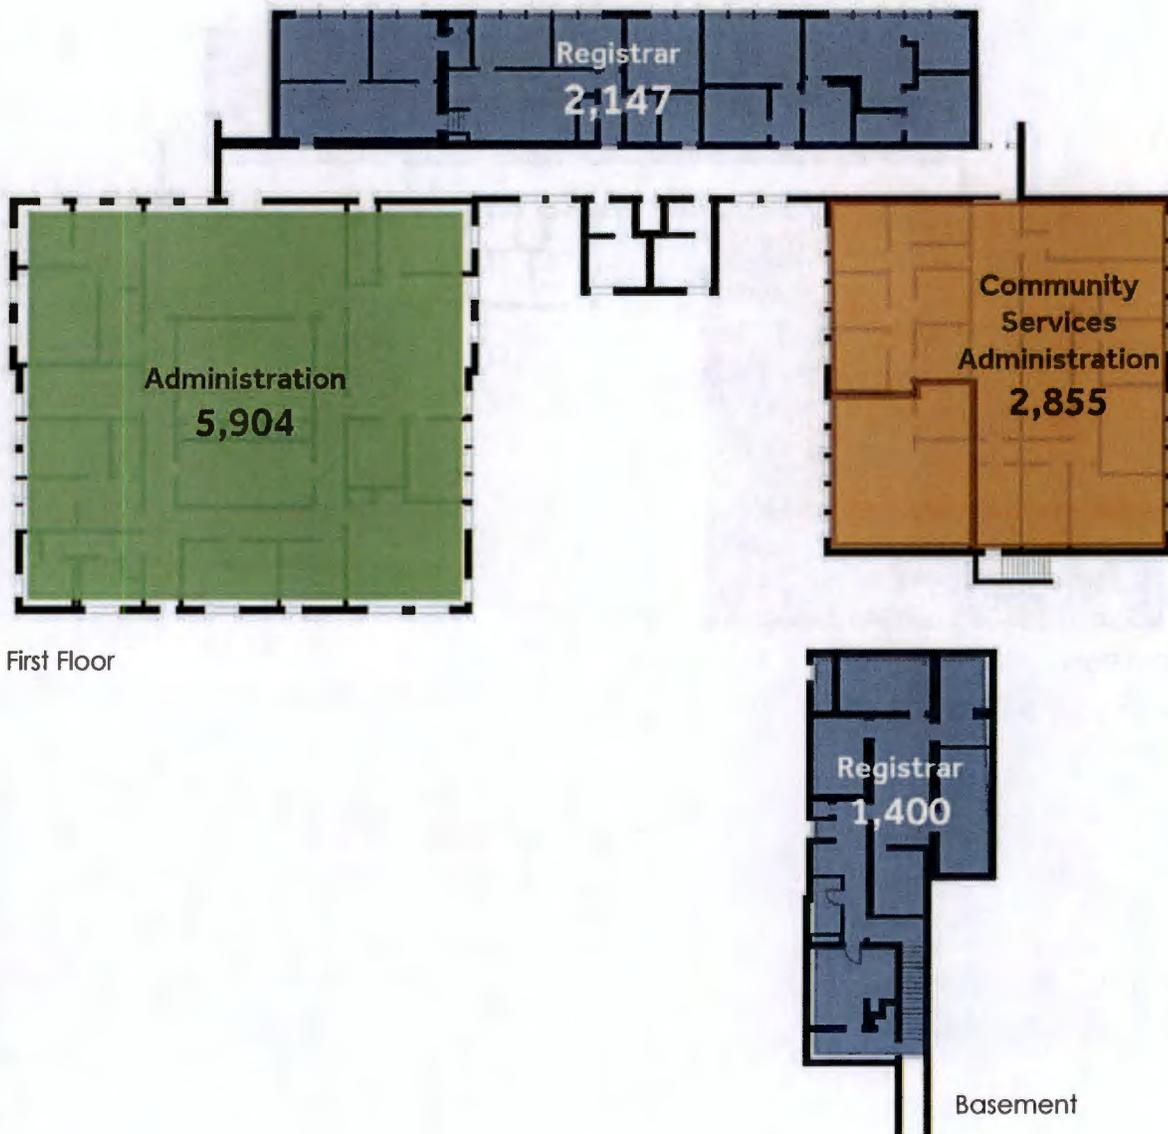
Figure 2.9

Option 3 – This option considers moving Economic Development out of the building and allowing the Registrar to expand along the front of the building and possibly utilize the basement for storage purposes.

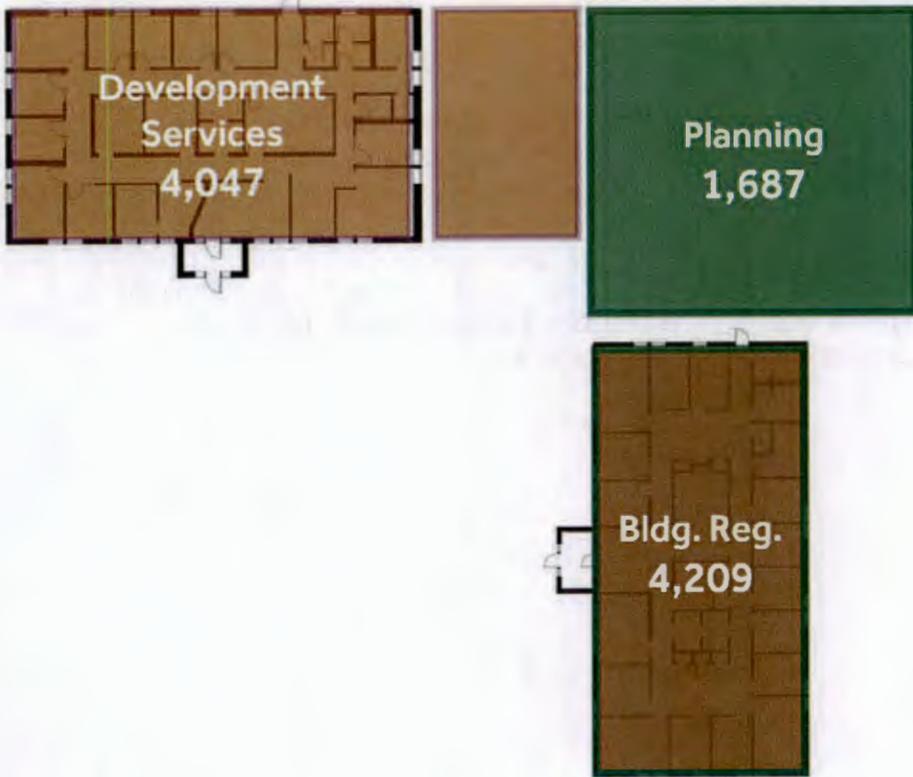
It is proposed to move the offices of Parks, Recreation and Tourism to another location and relocate Planning and Building Regulations to this site. The configuration shown in Figure 2.10 and Figure 2.11 proposes to relocate Building Regulations to the space vacated by Parks and Recreation and then construct a new infill addition where the Planning Department can be integrated into one facility where residents can come to access land and building development services. Such a facility will require a shared lobby, public restrooms, access to public meeting rooms and conference areas.
